TECHNICAL REPORT GL-81-2

15 MILE ROAD/EDISON CORRIDOR SEWER TUNNEL FAILURE STUDY DETROIT AREA, MICHIGAN

Geotechnical Laboratory
U. S. Army Engineer Waterways Experiment Station
P. O. Box 631, Vicksburg, Miss. 39180

January 1981

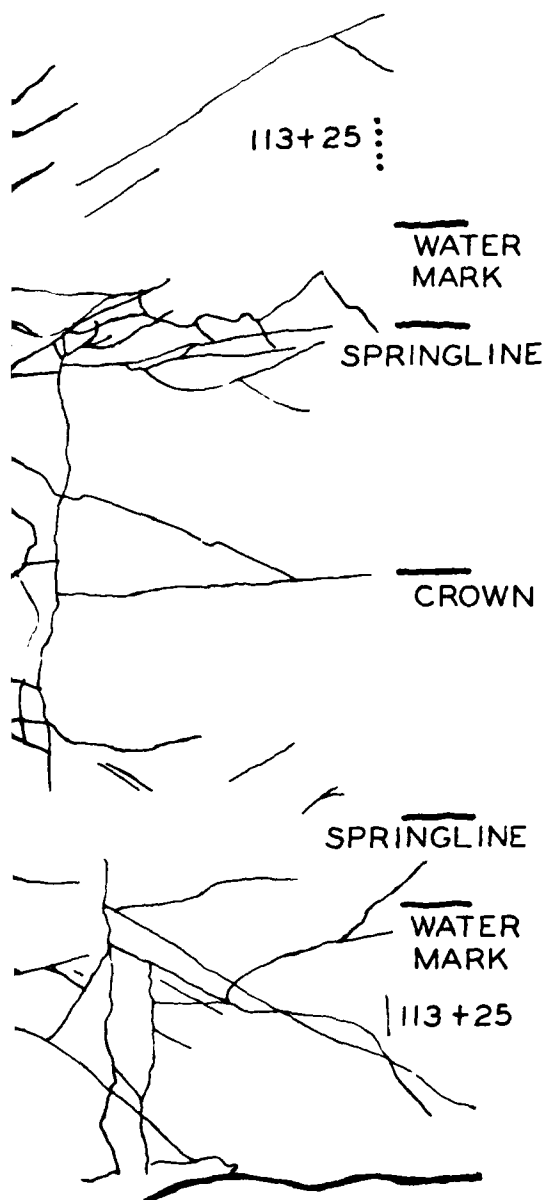
Figure 46.

46. Crack pattern, Distressed
Area 3

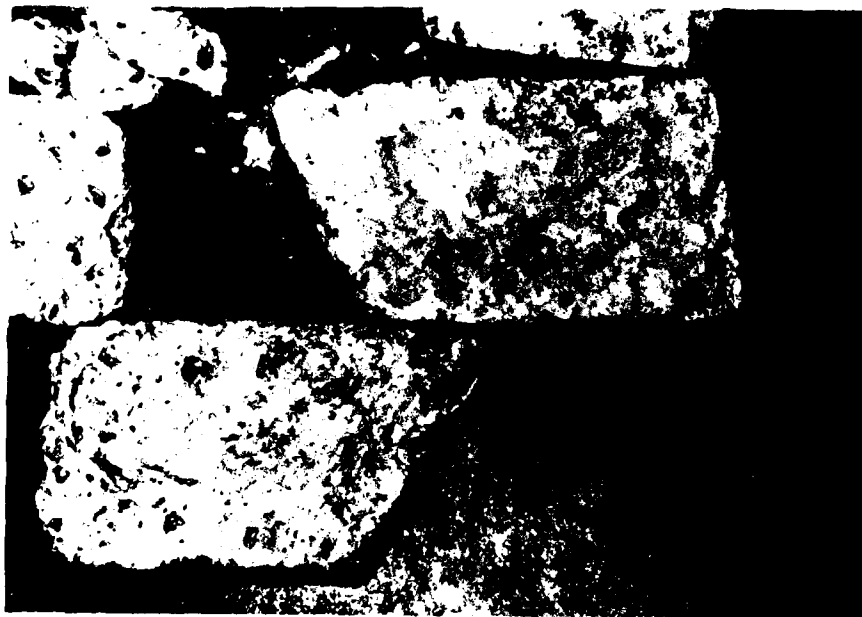
Figure 48. Above are DET-4 CON-21 crack surfaces opened along crack to show sediment coating
